**SITE ASSESSMENT REPORT  
FOR  
THE TOLEDO PLATE AND GLASS SITE  
TOLEDO, LUCAS COUNTY, OHIO  
TDD: T05-9204-016  
PAN: EOH0959SAA  
TAT-05-23-02024**

May 7, 1992

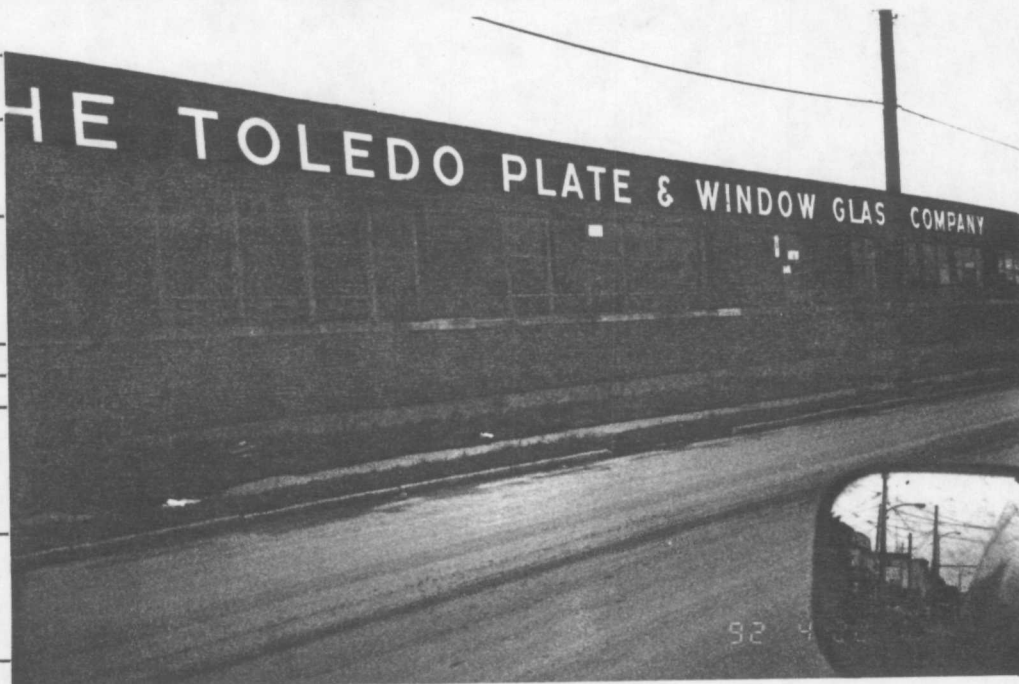
DESCRIPTION: View of site from LaGrange Street.

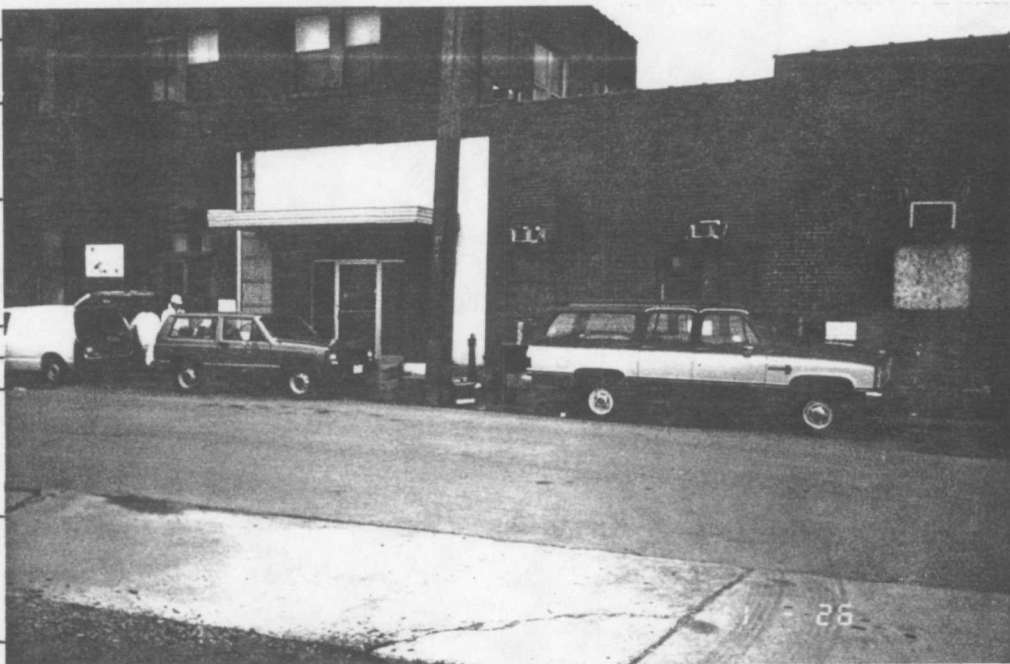
DESCRIPTION: Site entry was via an open door (left side of photo) on Utica Street.

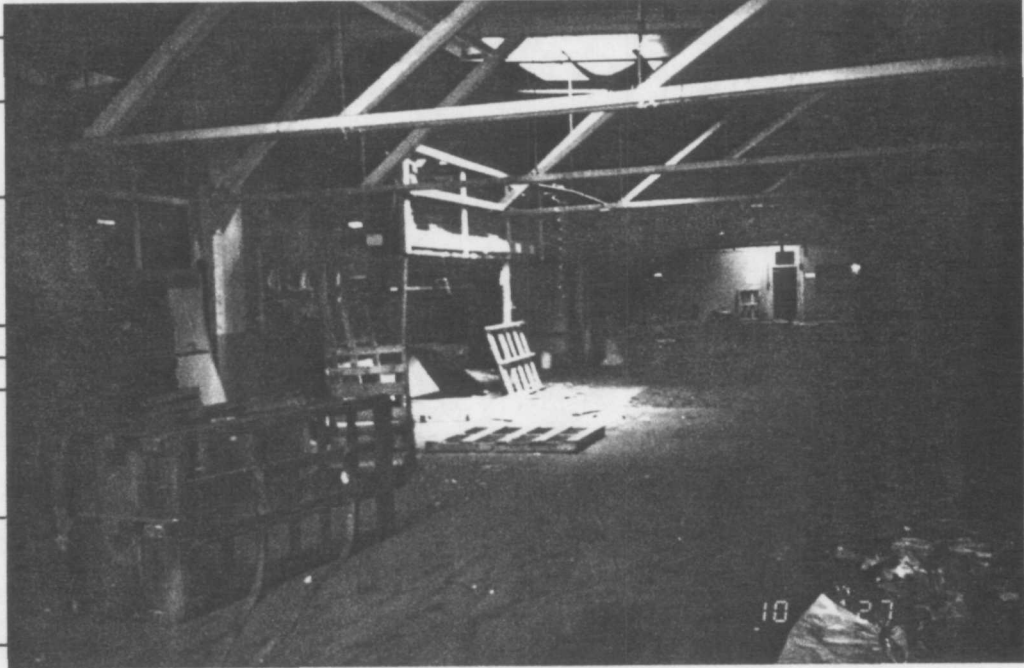
DESCRIPTION: Interior space on main floor.

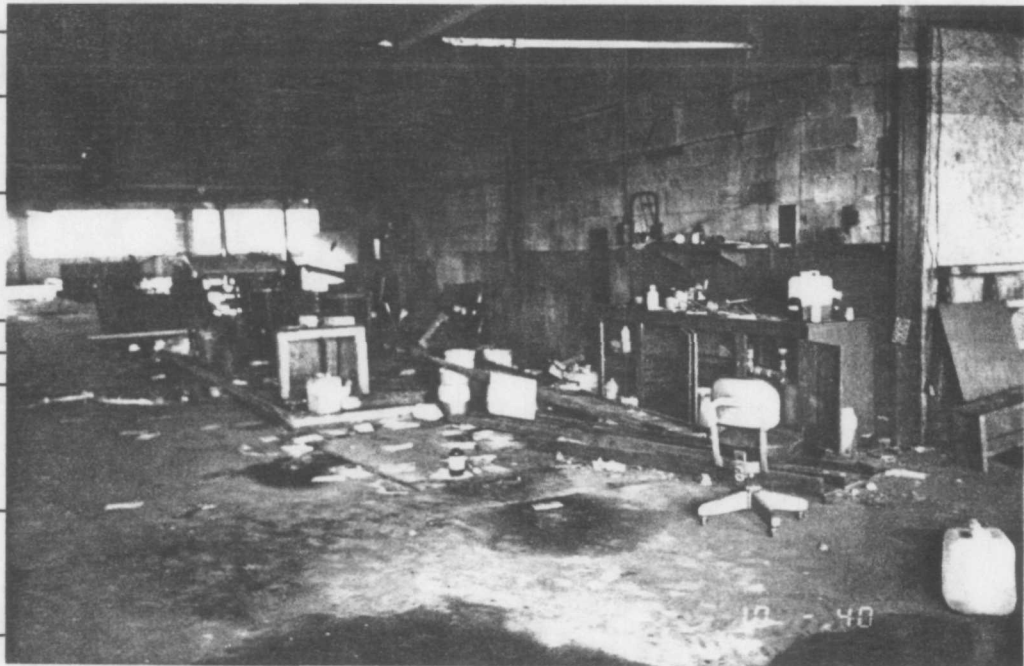
DESCRIPTION: Lab area in center of main floor.

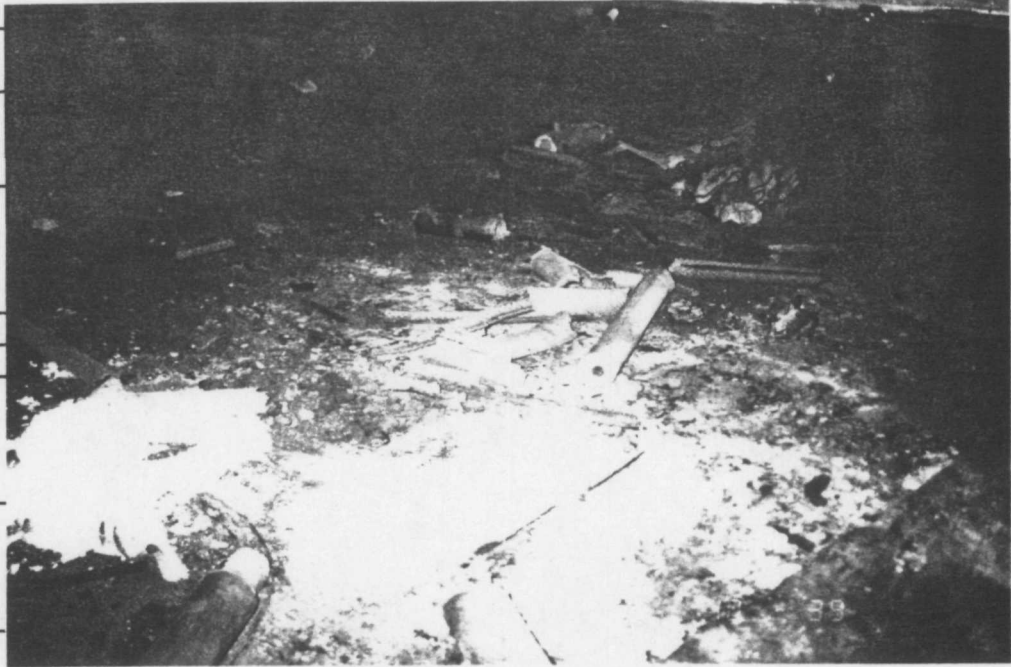
In addition, potential asbestos-containing materials were found at the TPG site. Asbestos is considered a human carcinogen by the International Agency for Research on Cancer (IARC), a hazardous substance, and a priority pollutant. Airborne asbestos from the TPG facility could migrate outside the facility through broken windows.

DESCRIPTION: Asbestiform material on floor adjacent to lab area.

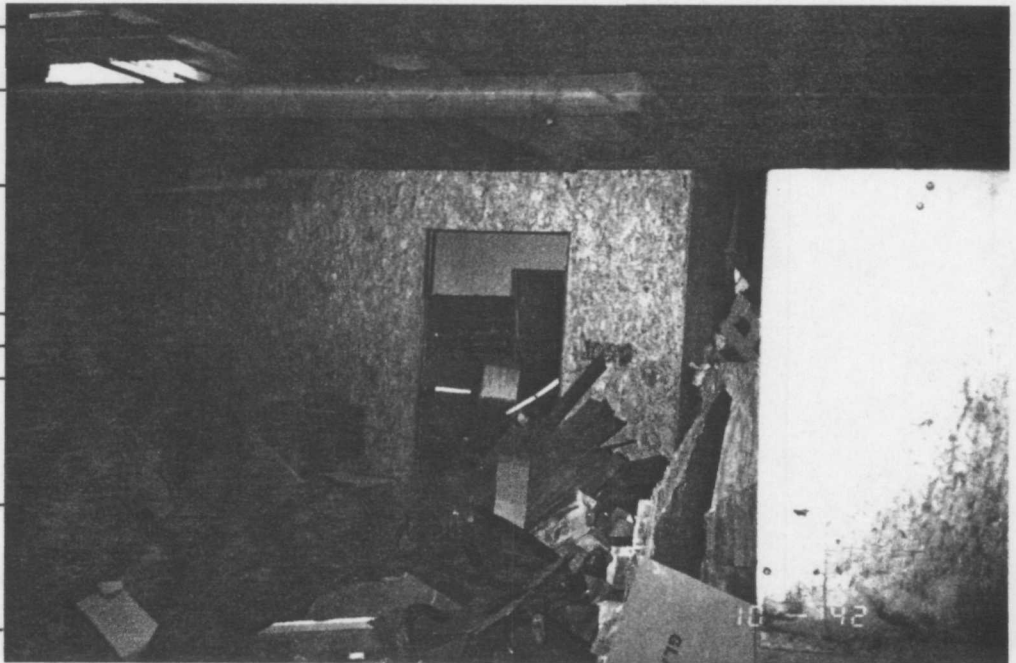
DESCRIPTION: View of site conditions, main floor.

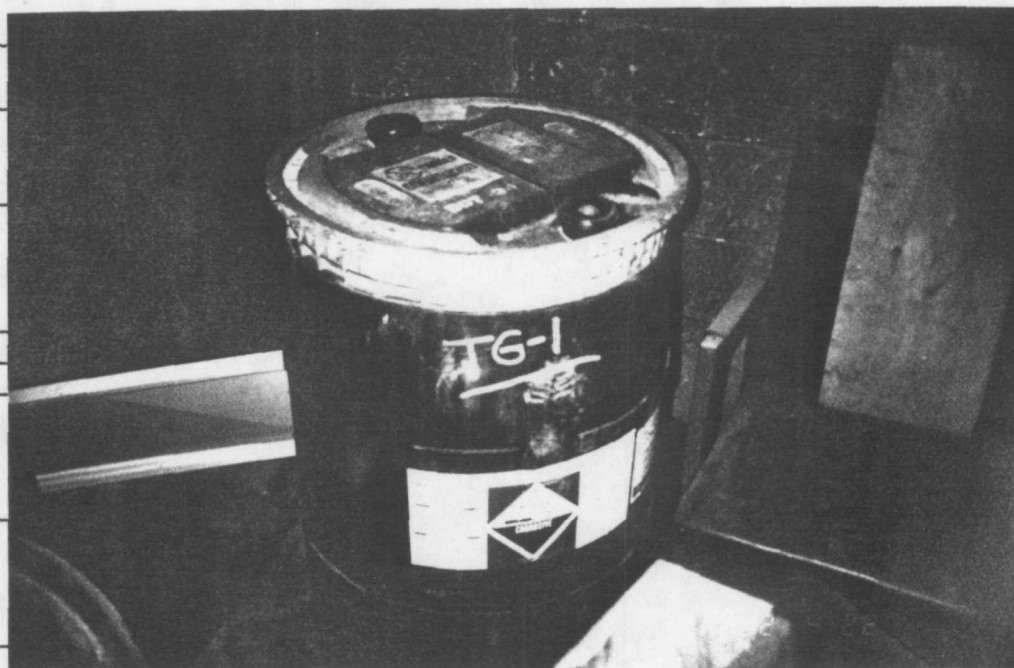
(if applicable): TG-1

DESCRIPTION: Plastic 55-gallon drum labelled as caustic soda liquid. Field screened pH = 6-7.

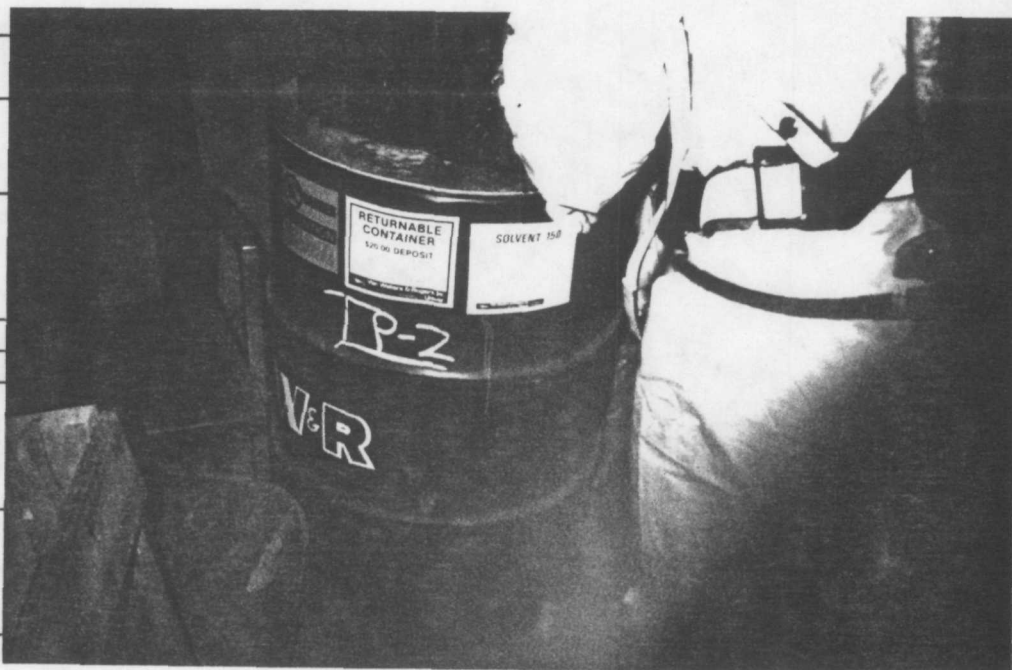
(if applicable): TG-2

DESCRIPTION: 55-gallon steel drum labelled as a solvent containing petroleum naptha.

Laboratory analysis indicates that the content's flashpoint is greater than 140F, and has a pH of less than 1.

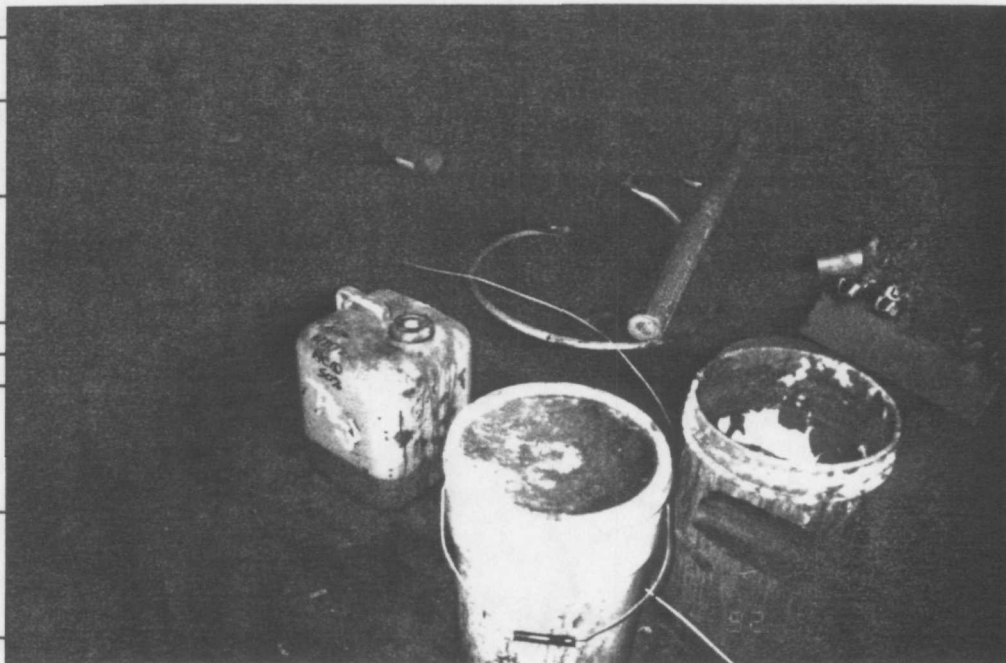
SAMPLE ID  
(if applicable): TG-3

DESCRIPTION: Plastic 5-gallon jug whose content was field tested to have a pH of 0-1.

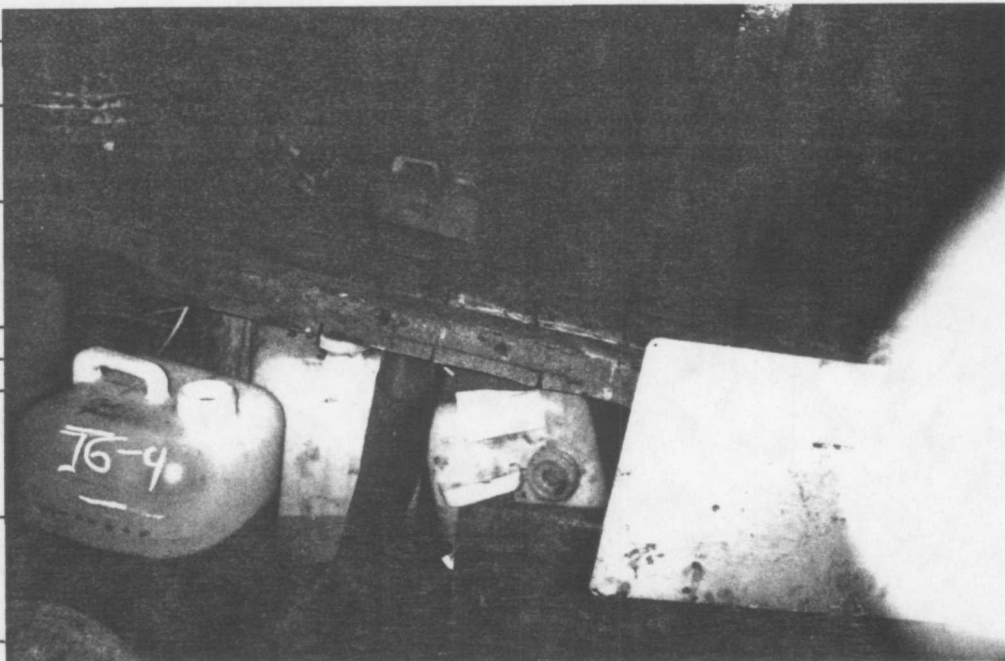
SAMPLE ID  
(if applicable): TG-4

DESCRIPTION: Plastic 5-gallon jug of liquid whose pH was field tested at 0-1.

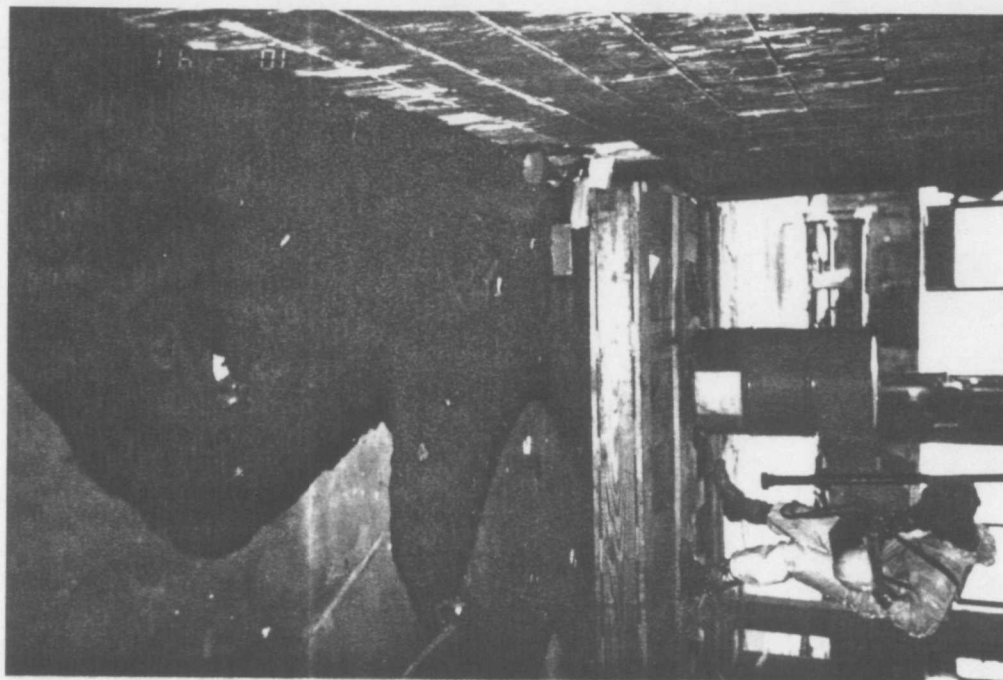
DESCRIPTION: Leaking drum on main floor of building.

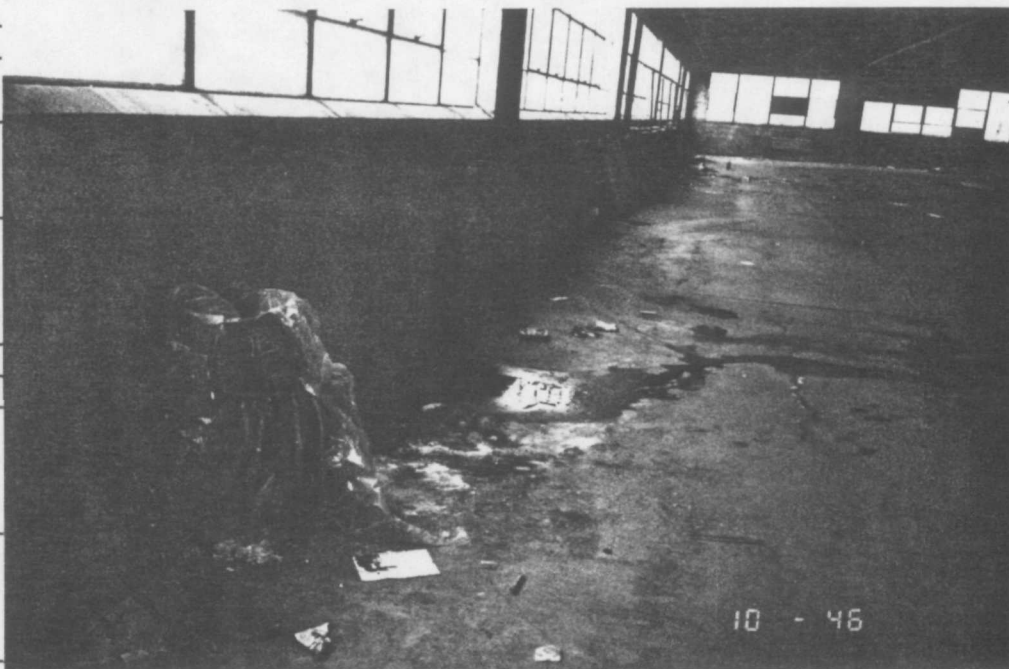
DESCRIPTION: 55-gallon drum half-full with a white powdery material, main floor.

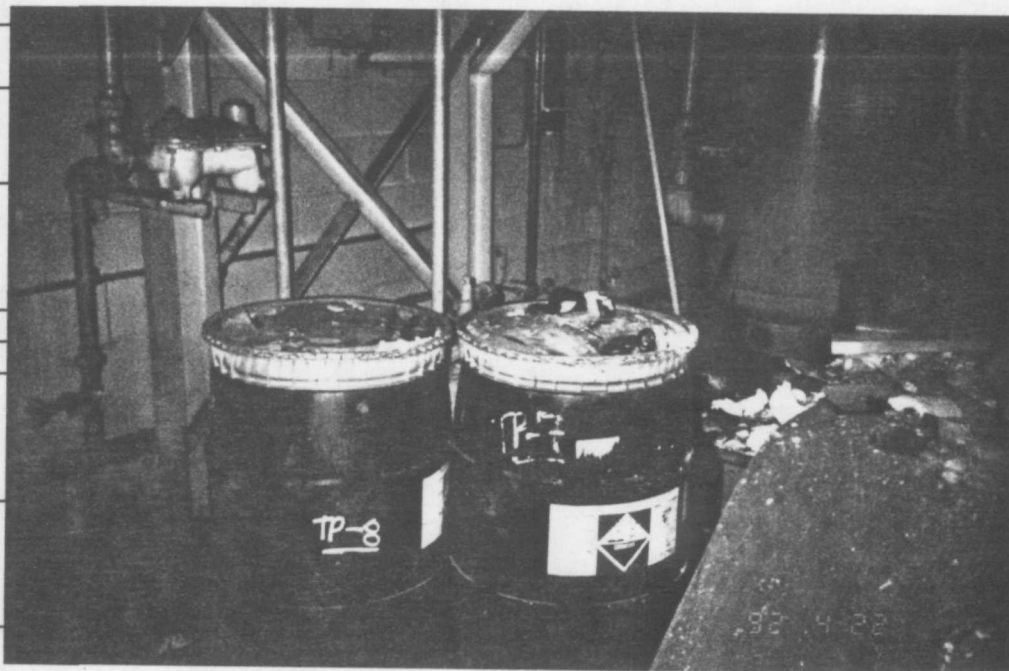
SAMPLE ID  
(if applicable): TG-7, TG-8

DESCRIPTION: 55-gallon drums in a room on the main floor's northwest side.

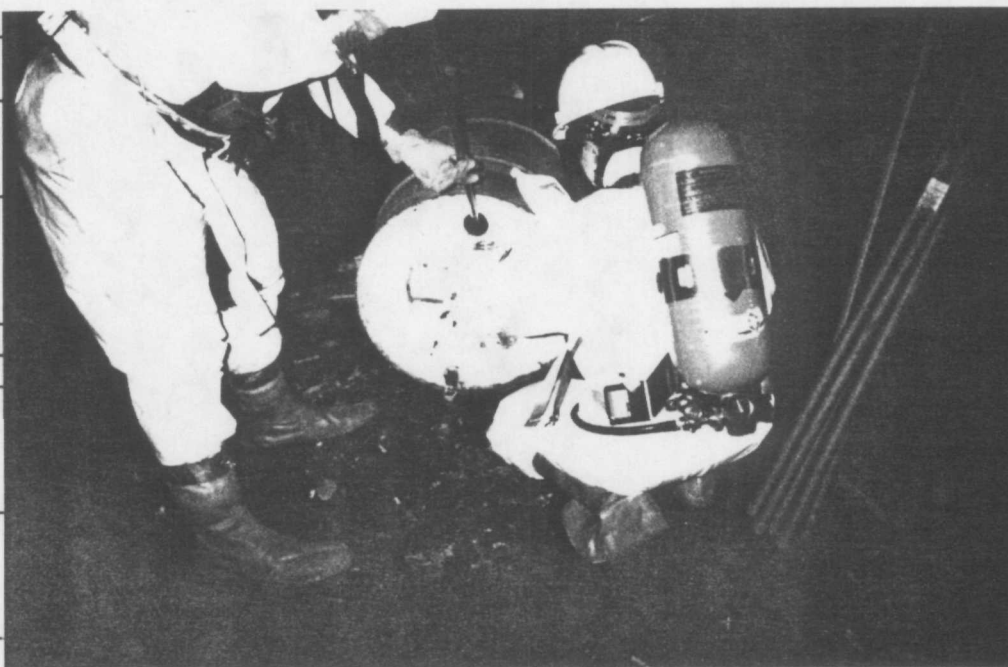
SAMPLE ID  
(if applicable): TG-10

DESCRIPTION: TAT members Fodo and Wong sample contents of drum labelled as a degreaser in a room on the northeast side of the building, main floor.

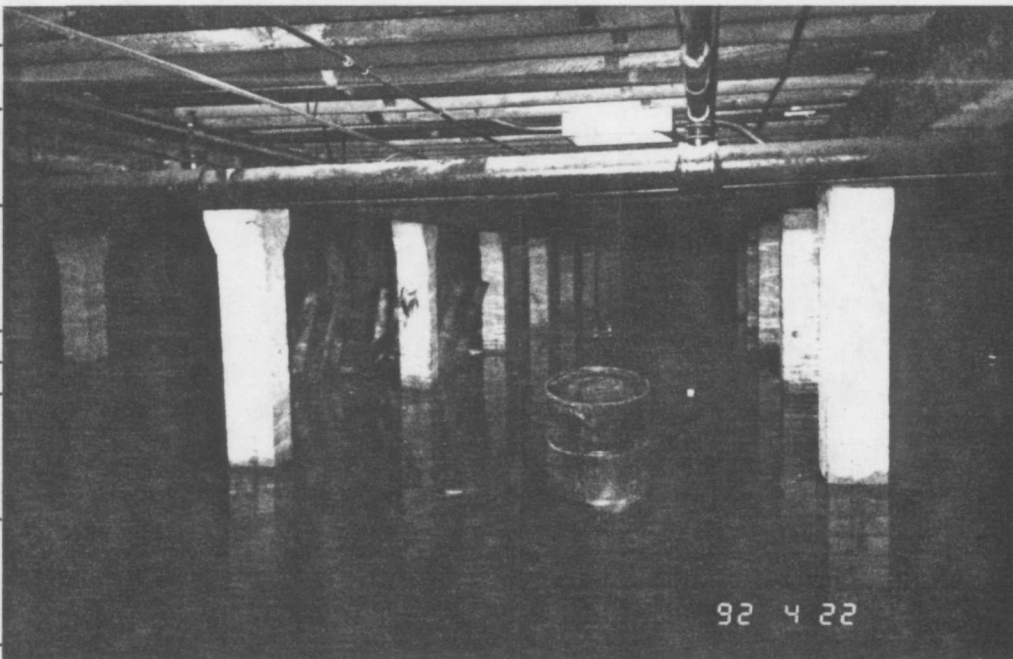
The basement of the TPG site was flooded with approximately 12 inches of water. Partially full drums and containers of hazardous materials were floating on top of the water. Many of these drums and containers were in poor condition, potentially allowing hazardous substances to escape. Drums and containers in the water are especially susceptible to rusting, promoting drum failure, and causing a hazardous materials release.

DESCRIPTION: View of basement conditions. The entire basement was flooded with 6-8" water.

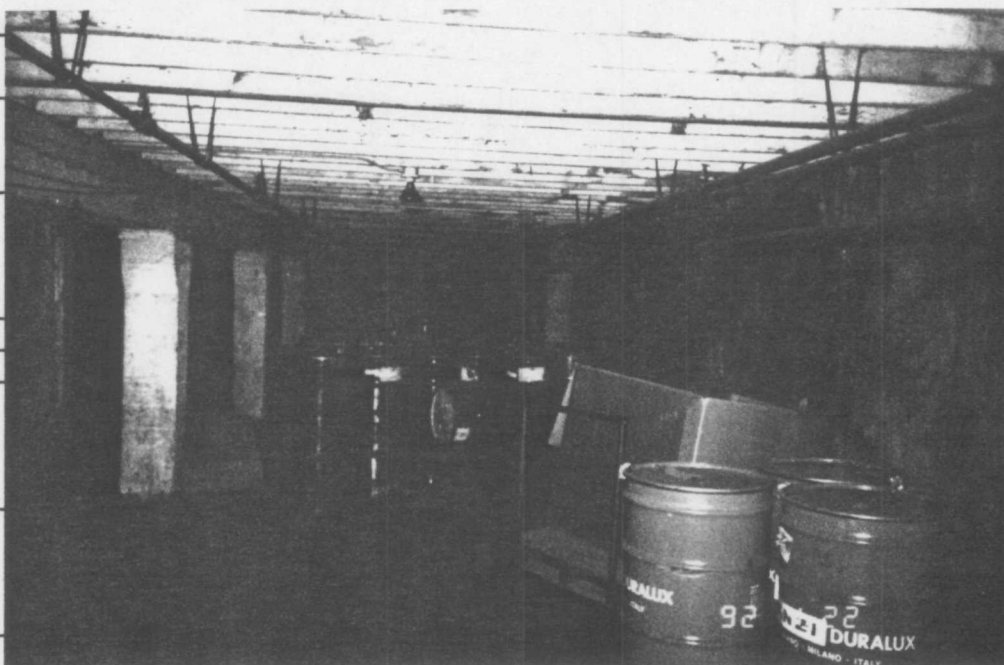
DESCRIPTION: View of drums labelled as lead-based paint.

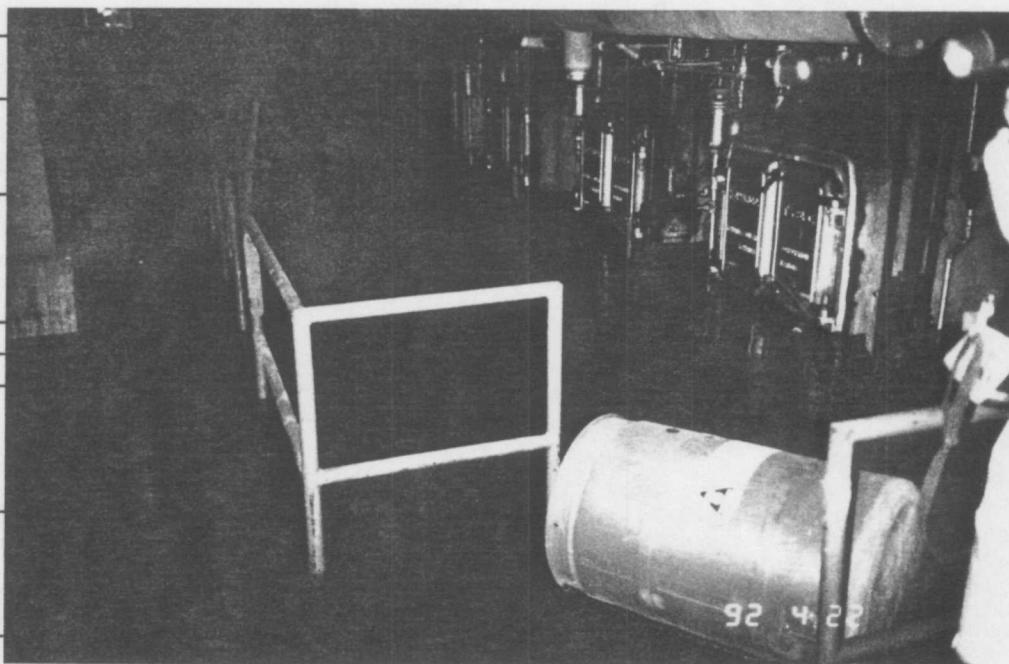
DESCRIPTION: View of basement boiler room.

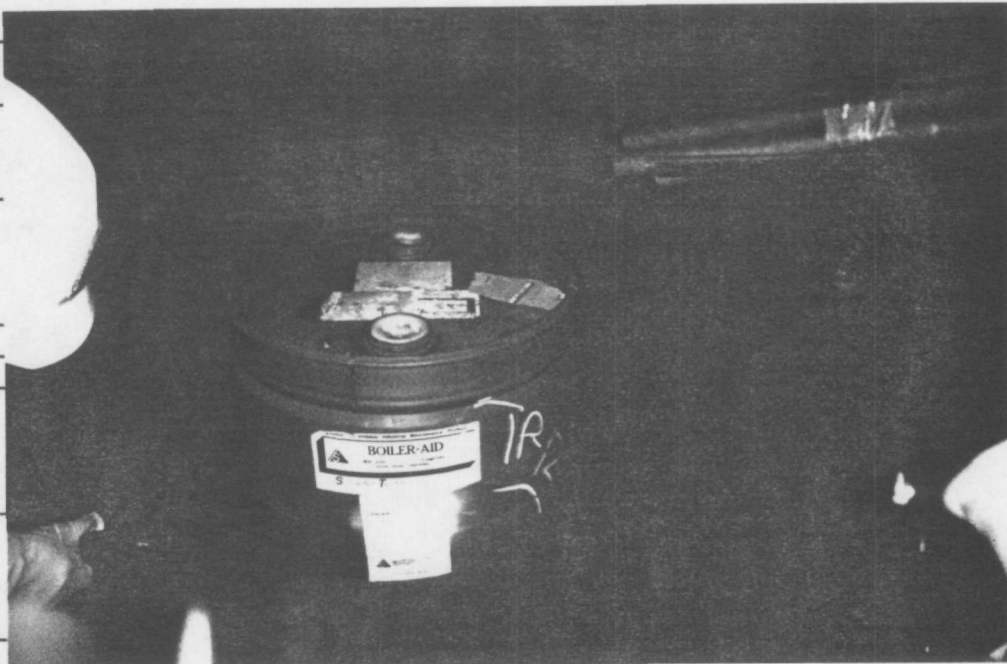
SAMPLE ID  
(if applicable): TG-12

DESCRIPTION: Plastic 55-gallon drum labelled as Boiler Aid (potassium hydroxide).

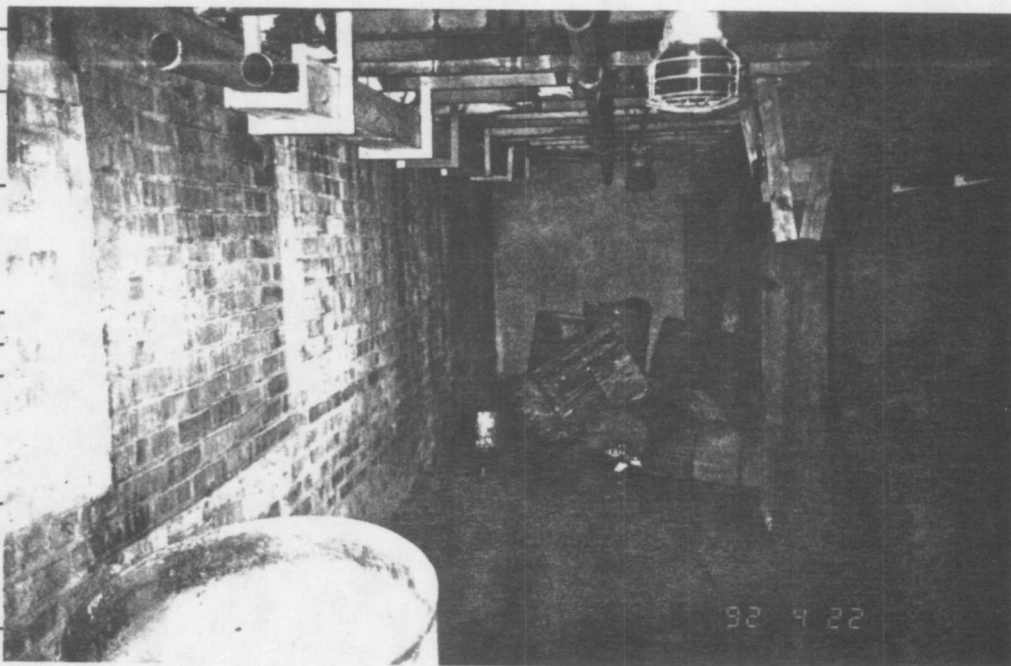
DESCRIPTION: View in basement showing conditions and several drums.

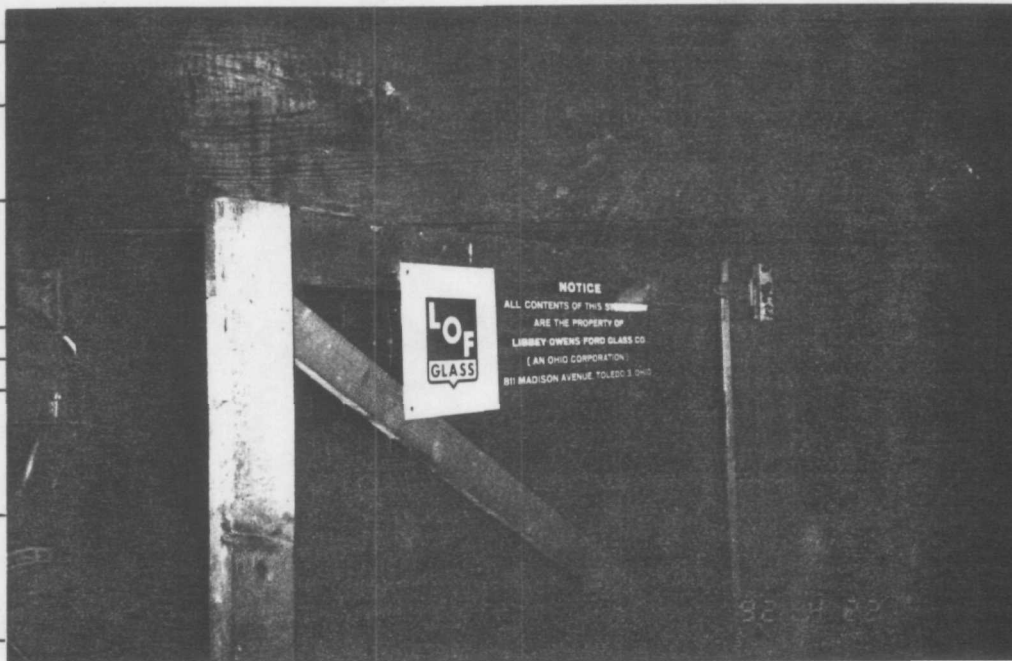
DESCRIPTION: Entrance to a basement storage room.

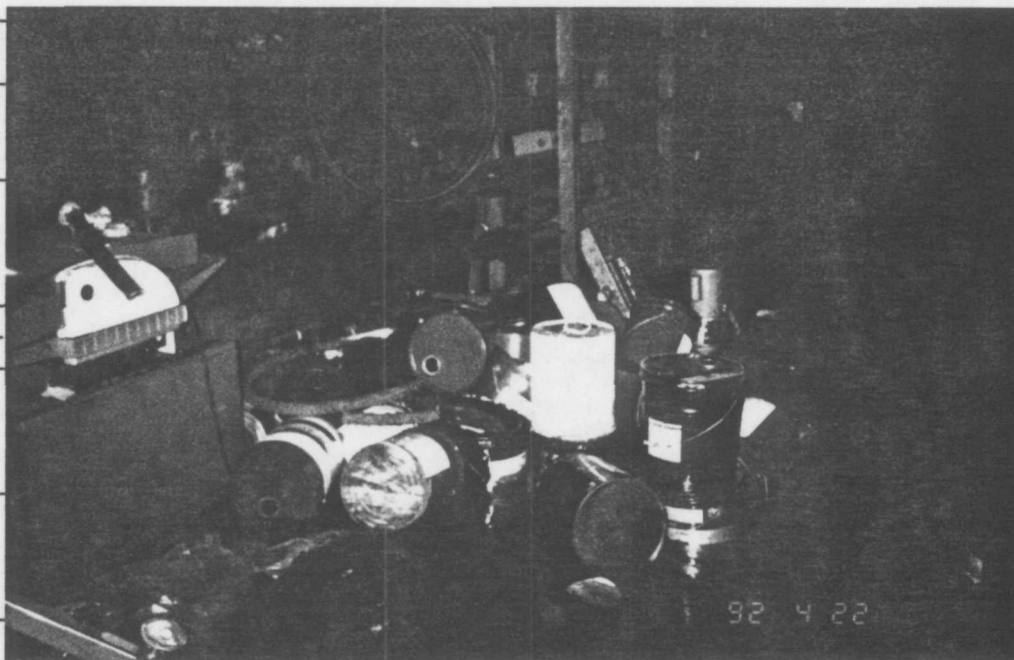
(if applicable): TG-13

DESCRIPTION: 5-gallon pails in basement storage room. Sample TG-13 (and duplicate TG-17) was taken from upright black pail in foreground.

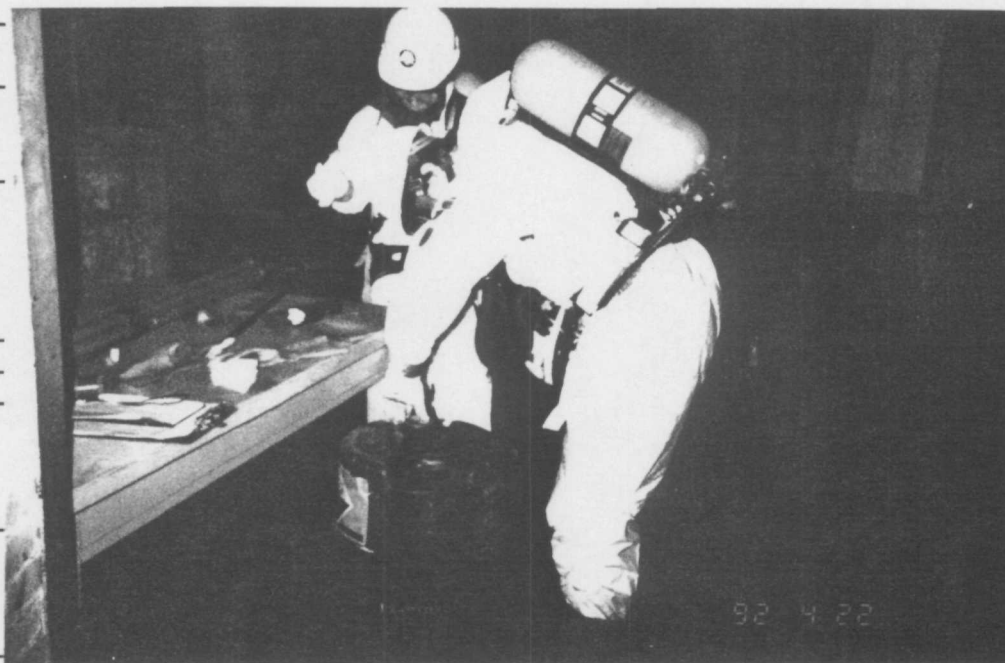
(if applicable): TG-11

DESCRIPTION: TAT members Fodo and Wong testing pH of small plastic drum labelled as Sulfuric Acid.

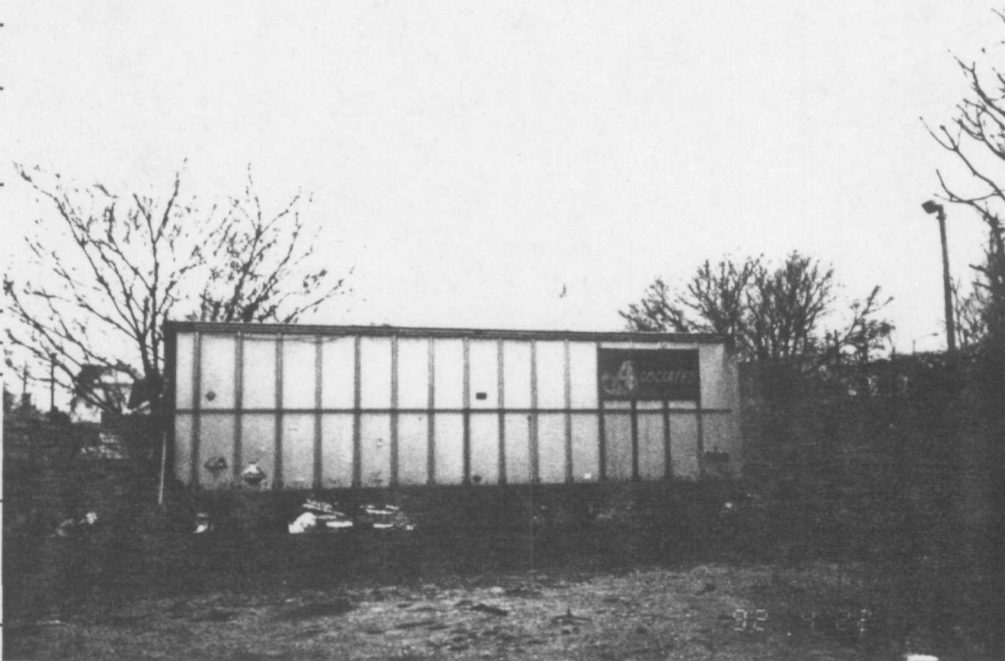
The TAT members then entered the trailer on the west side of Utica Street (Figure 5). The trailer, situated inside a fenced yard, was not secured, and not in good condition. Its stairs, tail gate, and support blocks were unstable. Twenty-eight 55-gallon drums and several 5-gallon pails were found in the trailer; no signs of leakage were observed on the trailer bed or on the soil below the trailer. HNu readings reached 5 to 10 units inside the trailer. Readings of 190 units were observed on the HNu while sampling drum TG14.

DESCRIPTION: Storage trailer on lot opposite building on Utica Street.

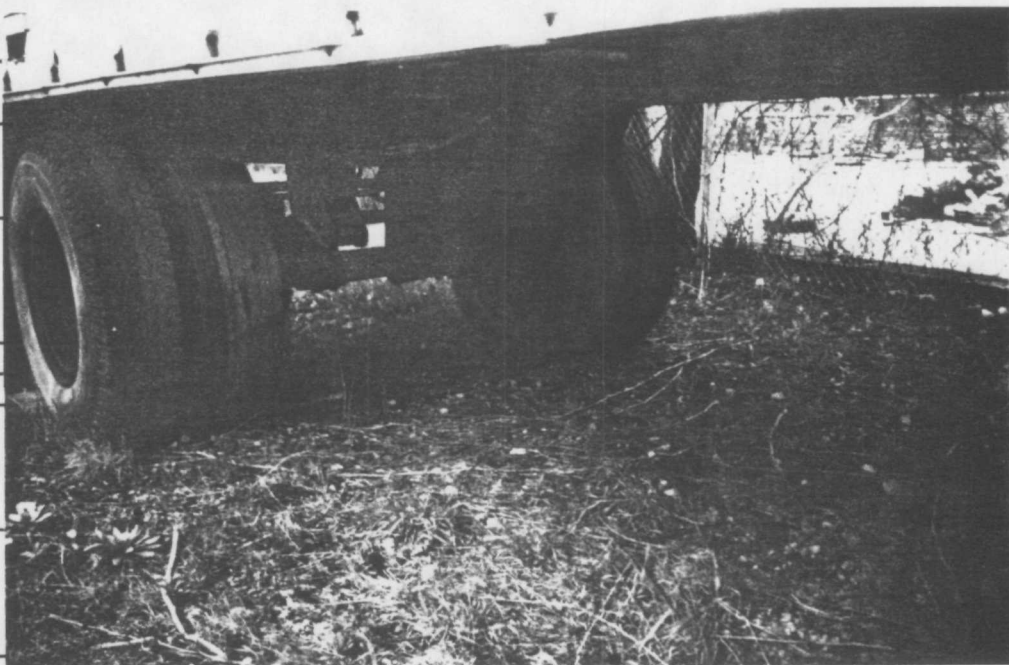
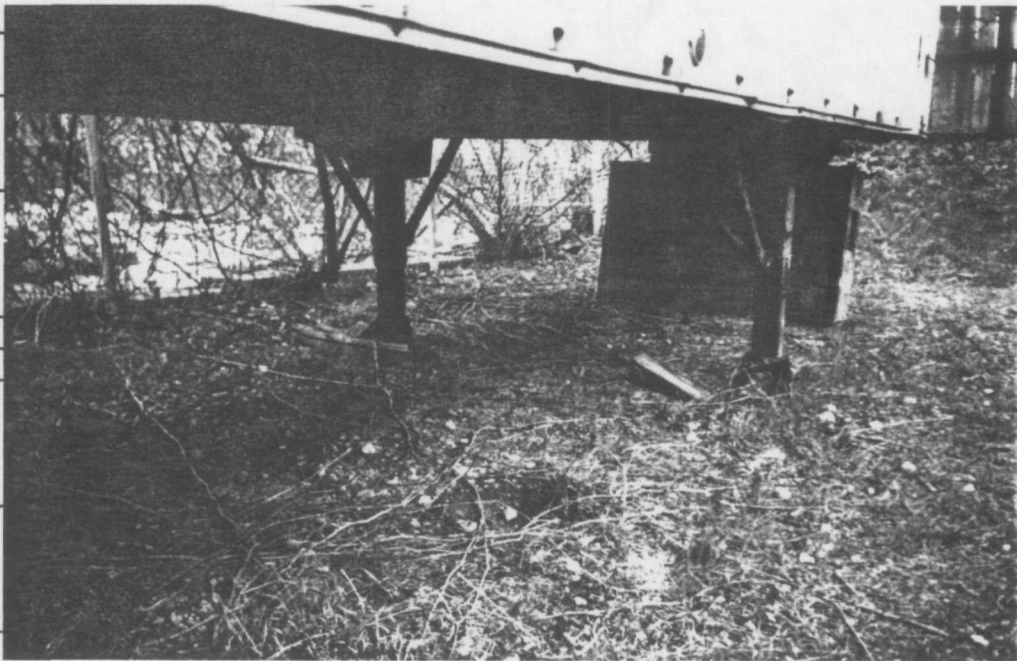
DESCRIPTION: No evidence of leakage from the trailer was present on the soil below.

DESCRIPTION: Same as above.

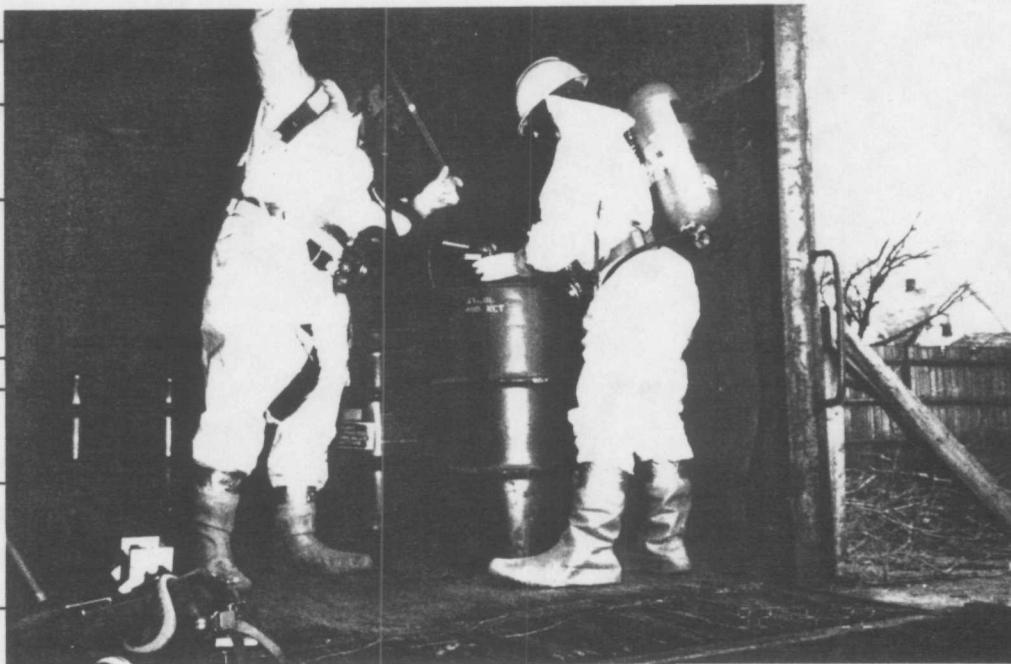
(if applicable): TG14

DESCRIPTION: TAT members Fodo and Wong sample colorless liquid which had an odor like xylene.

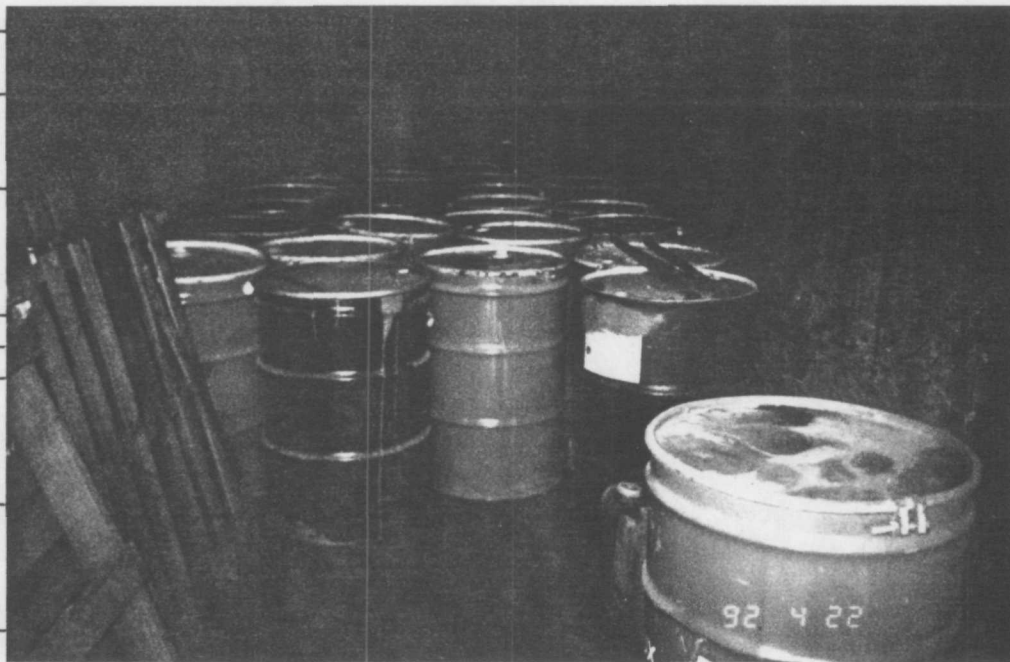
(if applicable): TG-15, TG-16

DESCRIPTION: View inside trailer.
